# An Investigation of Safety Hazards and Reliability Problems in Aerial Refueling Stores

by  
Leo D. Budd  
Fuze and Sensors Department

AUGUST 1980

NAVAL WEAPONS CENTER  
CHINA LAKE, CALIFORNIA 93555

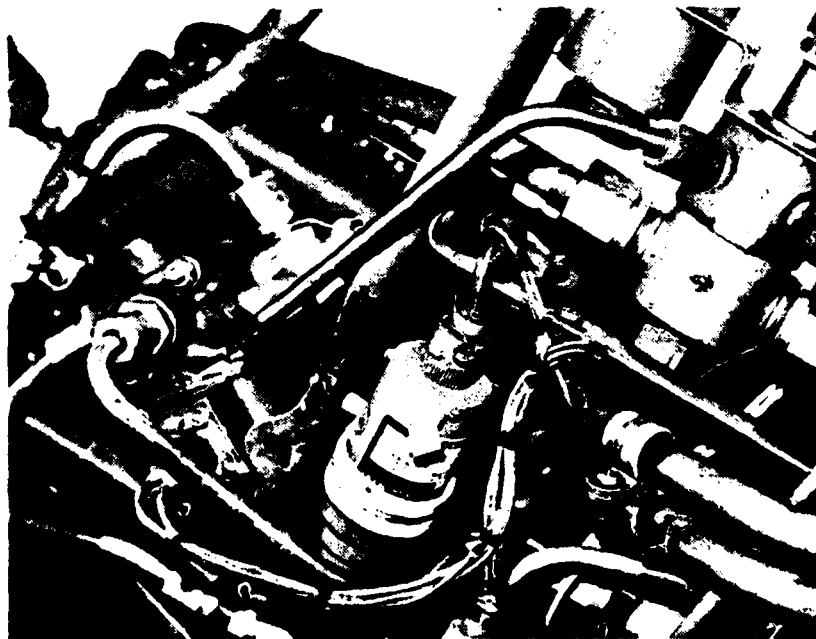
Two items that surfaced in the FMEA as possible design faults in the D-704 were checked by further observation of the store. The first was an ambient pressure vent for the fuel pressure regulator valve that appeared, in a schematic diagram, to be a possible path for fuel leakage into the tailcone section. As indicated in Figure 8, a trace of this vent port located its exit directly above the fuel pump hydraulic motor. The second item was a possible short circuit to the guillotine cartridge in a wire downstream of the hydraulic pressure switch (see Figure 9). It was determined that the guillotine wire could short to a 28-volt wire in that location or that the guillotine wire could become grounded.

FIGURE 9. View Looking up at Hydraulic Pressure Switch.
